GRAEF Project No.: 2013-0167

Tropical, Desert, and Show Dome Inspection Report

Mitchell Park Horticultural
Conservatory
524 S. Layton Blvd.
Milwaukee, Wisconsin

January 9, 2015

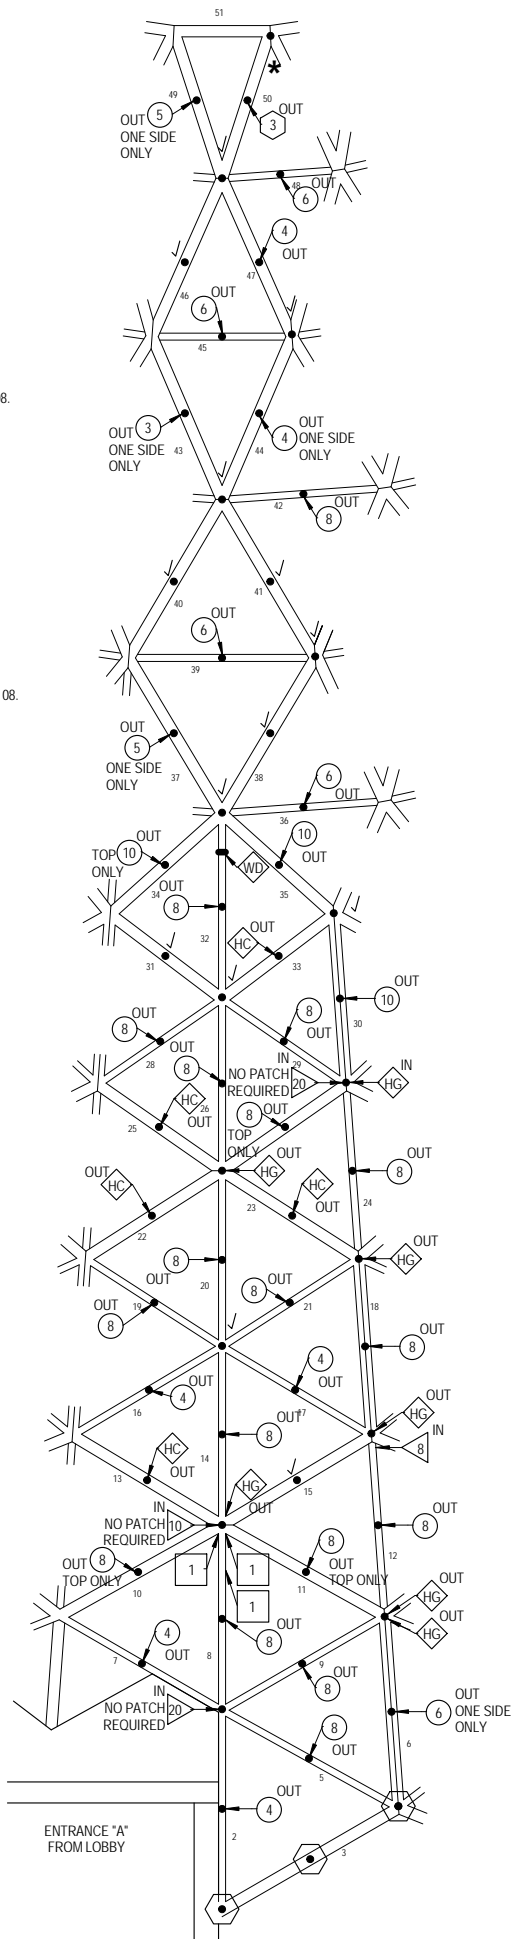
D125

- ⊗: OUTSIDE FACE OF BEAM OBSTRUCTED BY CONDUITS
- *: PAINT OUTSIDE FACE OF PLATE
- ◀: HOLE IN GLASS TO BE SEALED
- NOTE D: PREVIOUS CLAMP REPAIR; SURFACE RUST ON PLATES.

- NOTE E: DELAMINATED SURFACE GROUT KNOCKED OFF; NO ADDITIONAL REPAIR SPECIFIED.

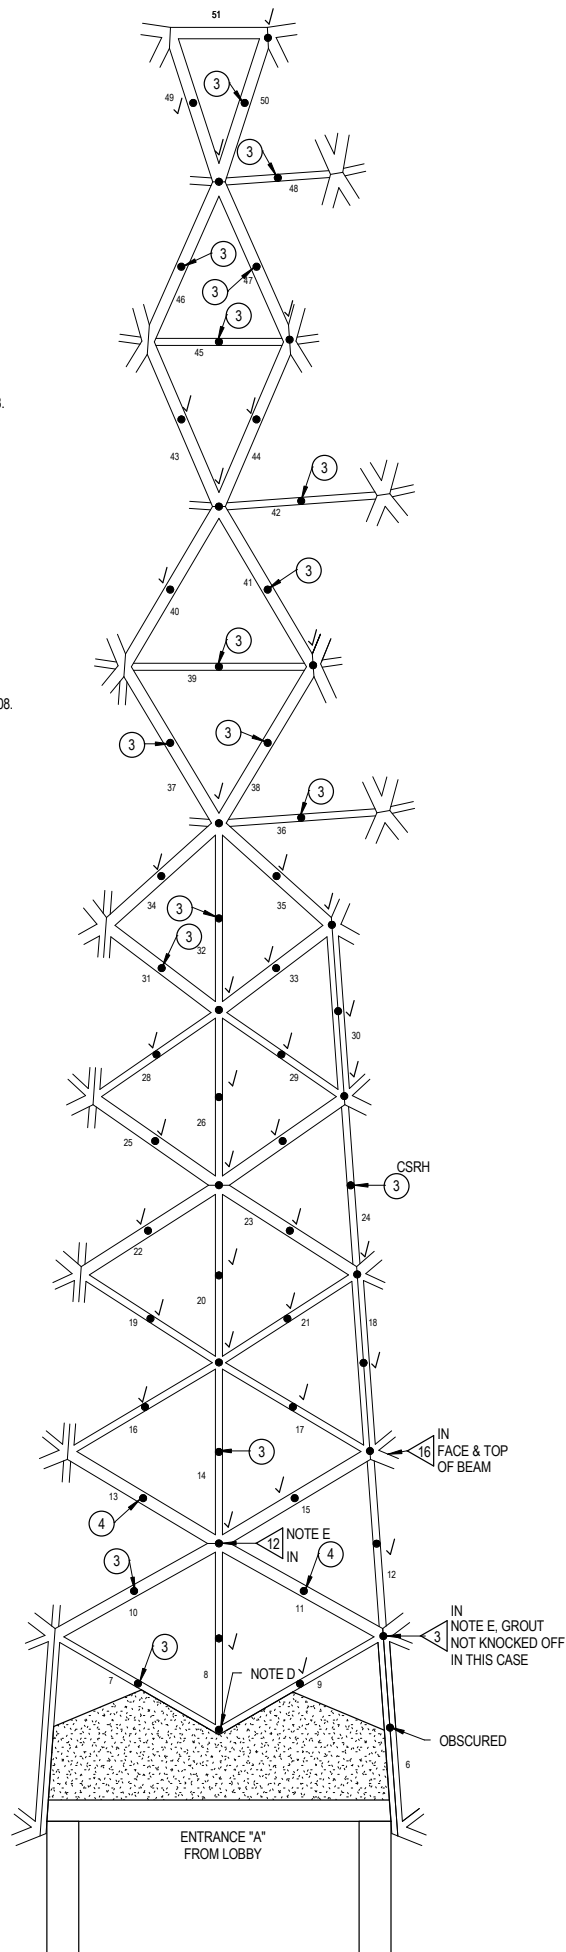
SD101

- ⊗: OUTSIDE FACE OF BEAM OBSTRUCTED BY CONDUITS
- *: PAINT OUTSIDE FACE OF PLATE
- ◀: HOLE IN GLASS TO BE SEALED
- NOTE D: GROUT SOUNDS SOFT ON SURFACE, BUT COULD NOT BE CHISELED / LOOSENED FOR REPAIR.

- NOTE E: DELAMINATED SURFACE GROUT KNOCKED LOOSE; NO ADDITIONAL REPAIR SPECIFIED.

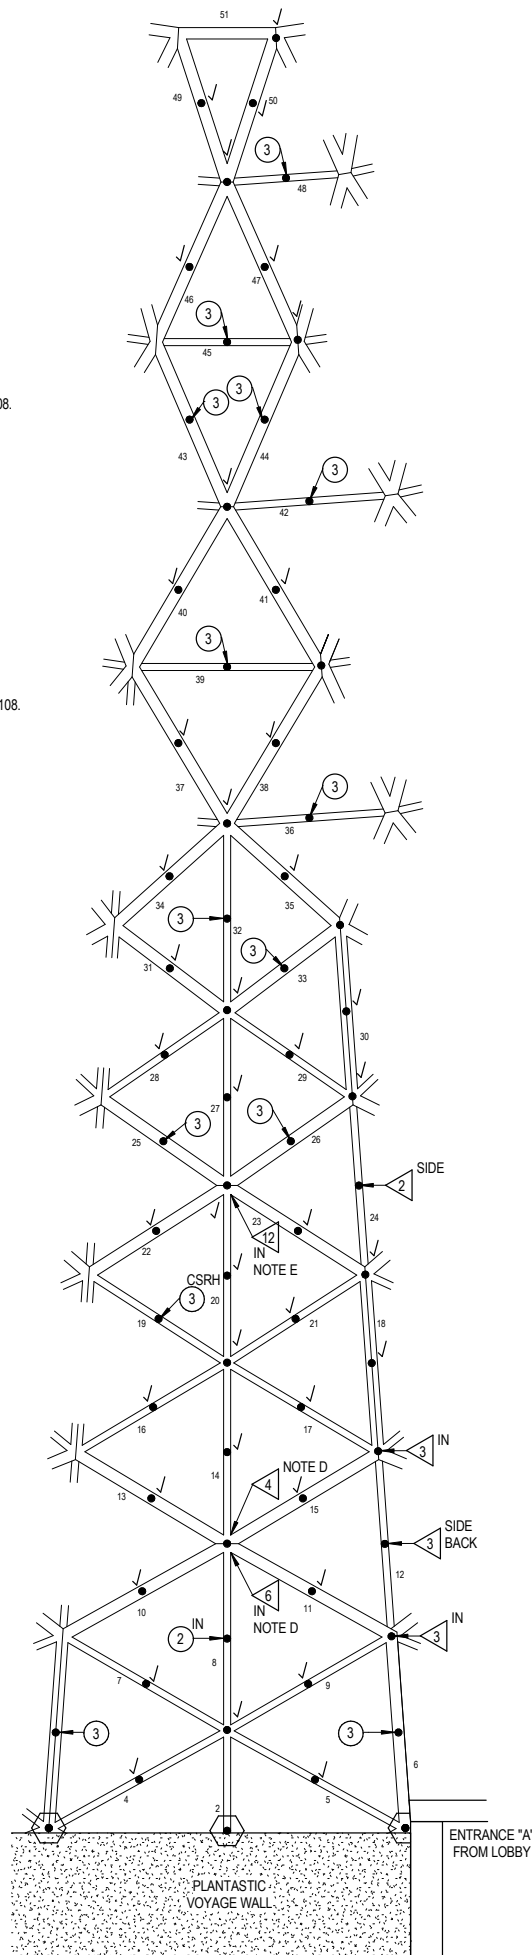
SD102

- ◀: HOLE IN GLASS TO BE SEALED
- NOTE D: DELAMINATED SURFACE GROUT KNOCKED LOOSE; NO ADDITIONAL REPAIR SPECIFIED.

- B: NOTE B: CONCRETE EROSION DUE TO PROLONGED WATER DRIPPING. NO REPAIR REQUIRED.
- C: NOTE C: PIECE OF WOOD EMBEDDED IN CONCRETE. REMOVE WOOD AND FILL WITH PATCHING MATERIAL SIMILAR TO DETAIL 5/S108.

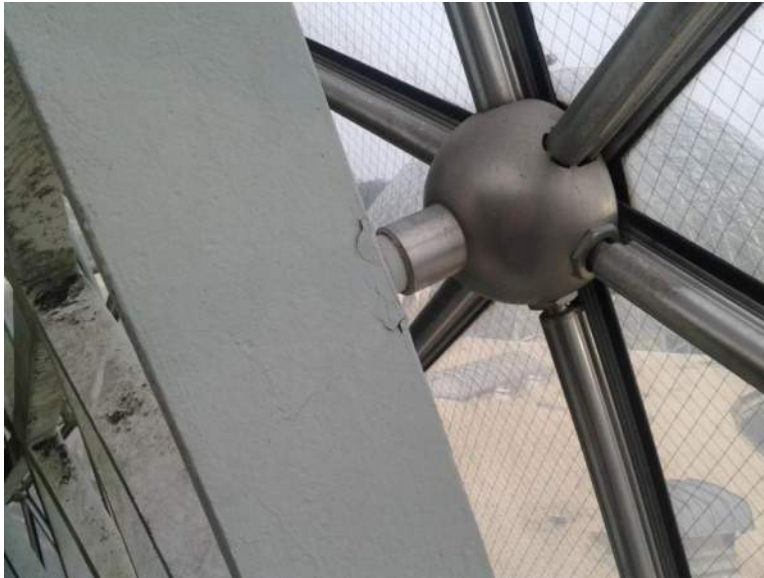
CONCRETE DETERIORATION AT EMBEDS

Photo F01: VISIBLE CONCRETE CRACKING AT CONNECTION OF GLAZING STANDOFF PIPE TO STRUCTURAL SPACE FRAME.

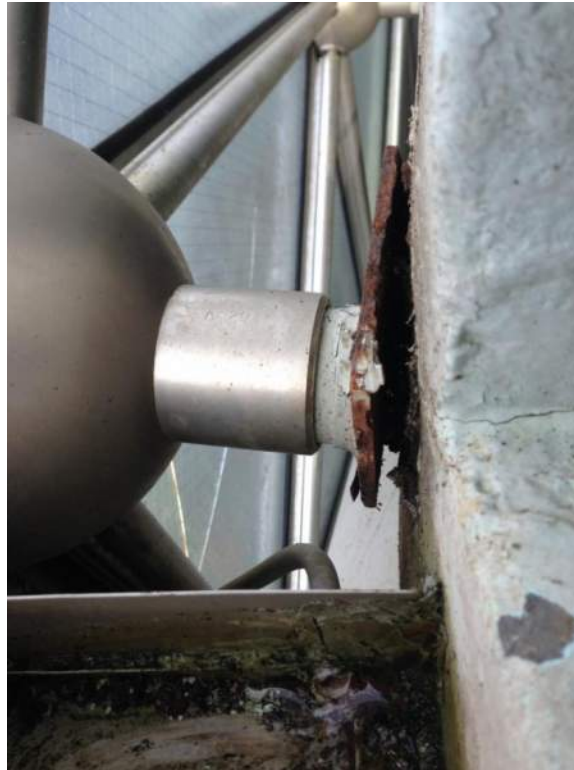
MISALIGNMENT BETWEEN GLAZING STANDOFF PIPE AND CONCRETE EMBED PLATE

Photo F03: MISALIGNED CONNECTION LEAVES GAP WHERE WELD CANNOT BE MADE ALONG THE BOTTOM EDGE OF PLATE.

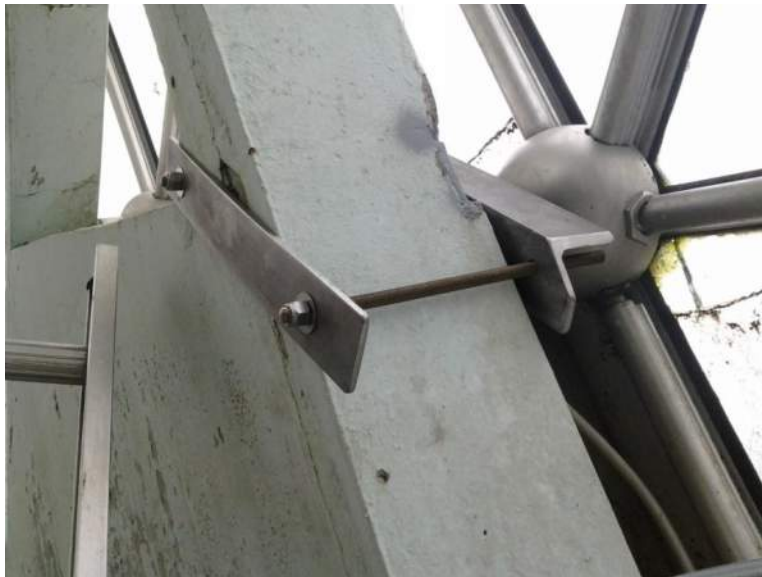
Photo F04: STAINLESS STEEL CLAMPS PULL MISALIGNED CONNECTIONS TIGHT TO SUPPORTING REINFORCED CONCRETE STRUCTURE.

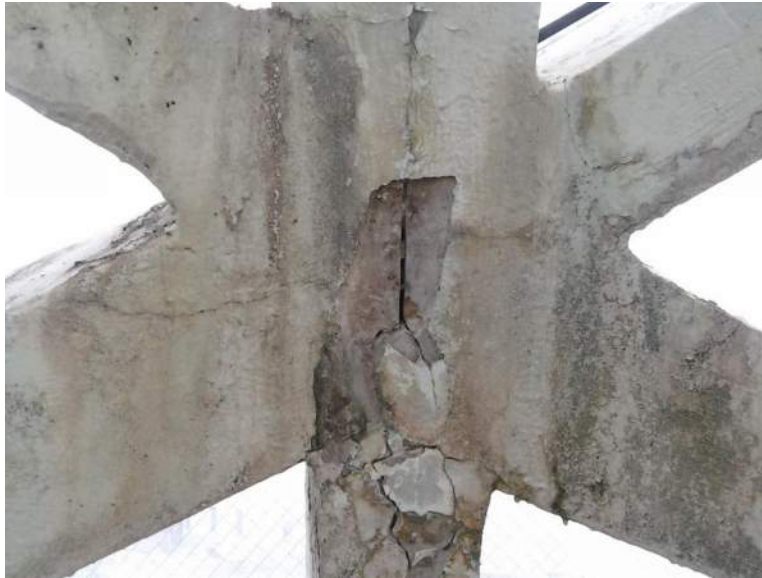
ERODED GROUT BETWEEN PRECAST UNITS

Photo F05: SOFT GROUT DETECTED AT JOINT BETWEEN PRECAST UNITS

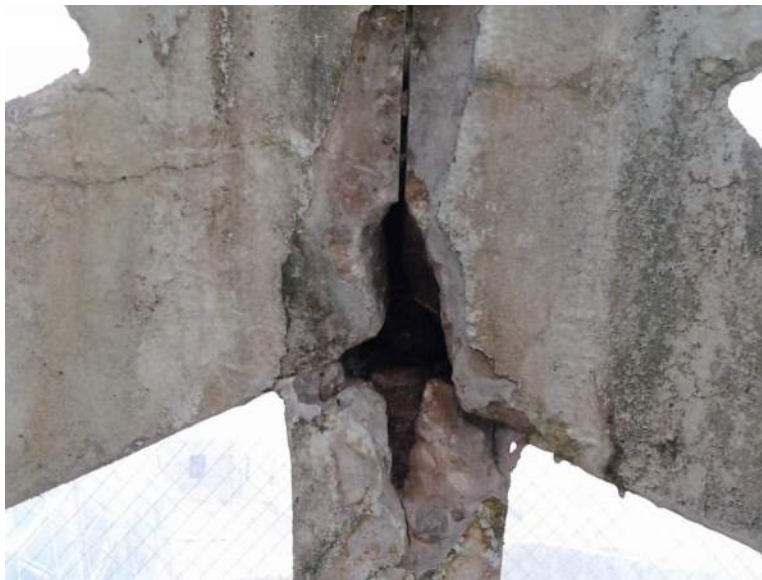
Photo F06: REMOVAL OF GROUT MAKES ROOM FOR NEW GROUT REPAIR

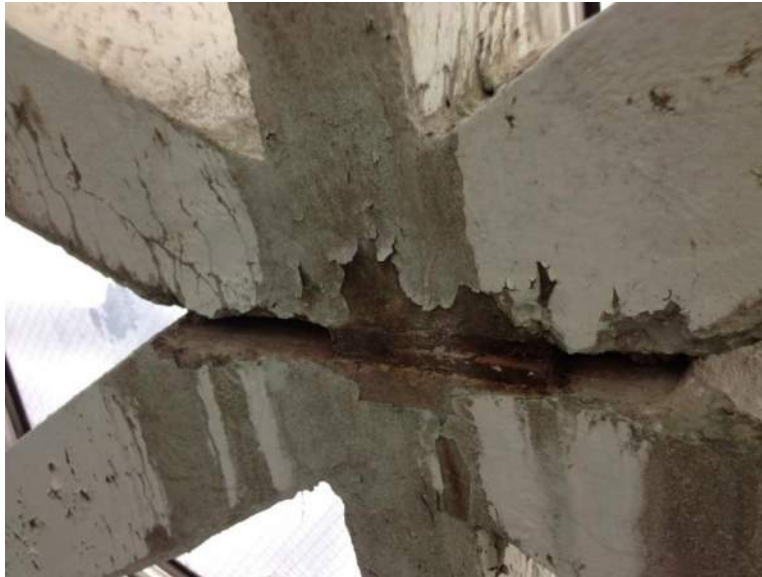
Photo F07: REMOVAL OF GROUT MAKES ROOM FOR NEW GROUT REPAIR.
CONNECTION PLATE EXHIBITS SOME RUST.

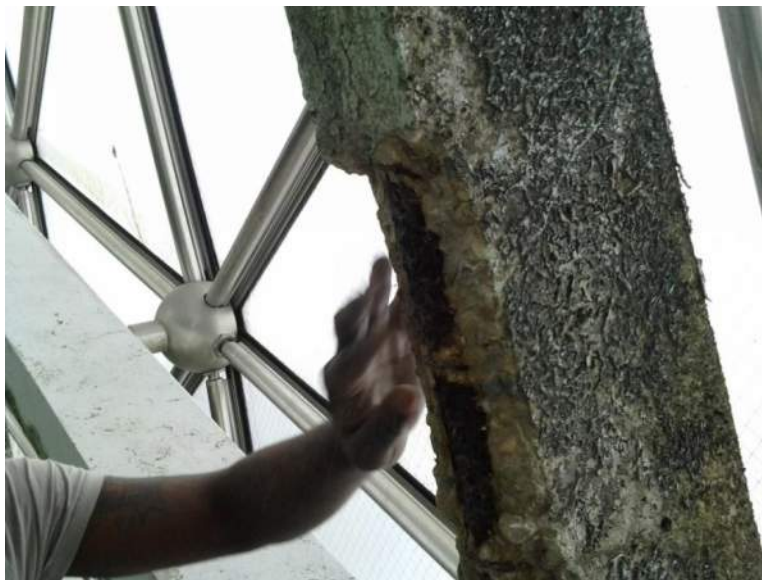
SPALLED CONCRETE AND EXPOSED STEEL REINFORCEMENT

Photo F08: CONCRETE SPALL EXPOSES RUSTY STEEL REINFORCING BAR. NO
SECTION LOSS OF THE BAR WAS OBSERVED.

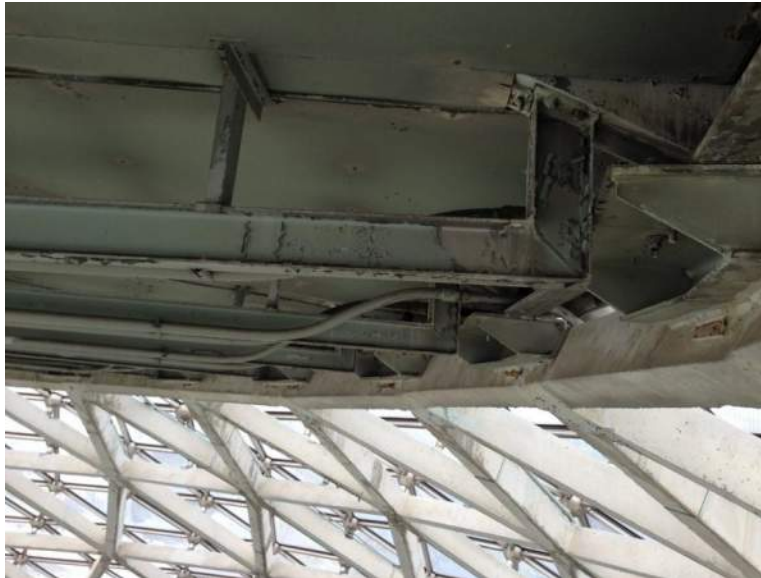
CORROSION OF APEX BOLTS

Photo F09: ALUMINUM FRAMING AT DOME APEX CONNECTS TO COMPRESSION RING OF REINFORCED CONCRETE SPACE FRAME DOME.

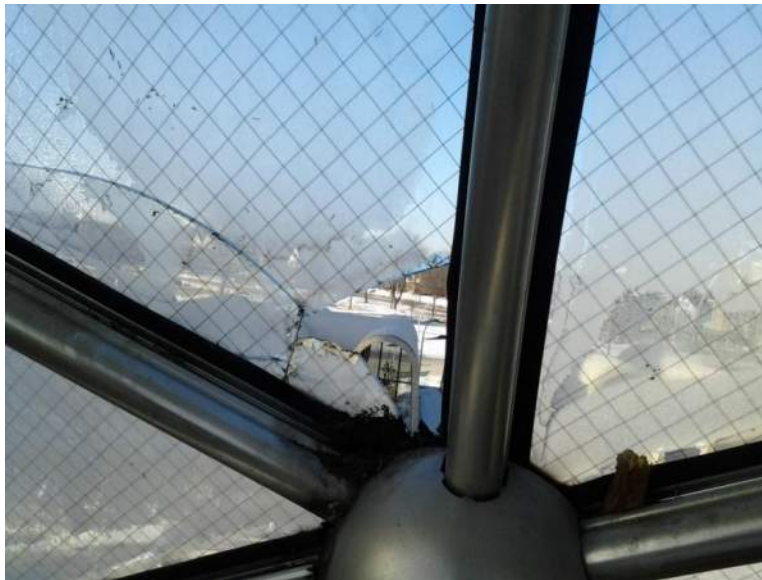
BROKEN GLASS

Photo F11: BROKEN GLASS LETS IN AIR AND MOISTURE.

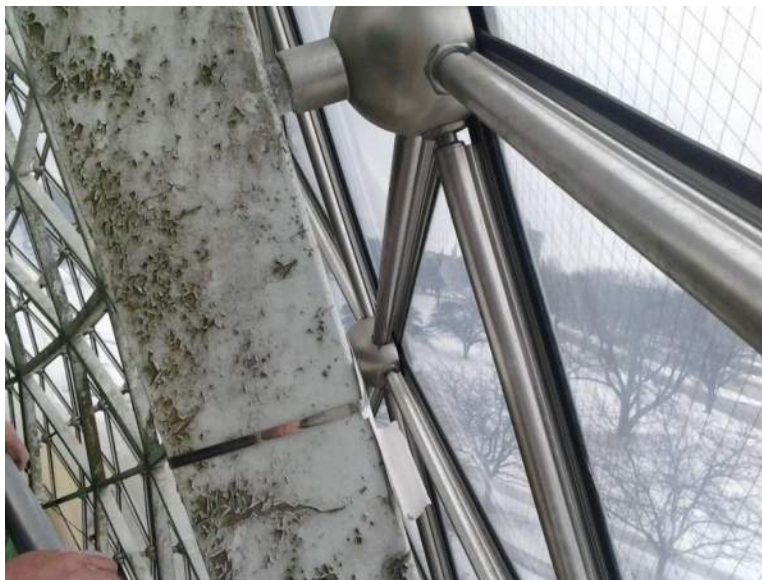
Photo F12: WATER DIVERTER INSTALLED BELOW HUB.
